XRF and Infrared Analysis of an 18th Century Portrait

An unsigned portrait painting from the 1700's, (Oil on canvas, 13" x 16") from an estate sale (shown in Fig. 1), was examined by the RevealScan™-M multispectral infrared system as well with an M6 X-ray Fluorescence Imaging device (Manufactured by Bruker Nano Systems of Berlin, Germany)¹. As the painting's artist is unknown, the examination was aimed at details to exploring the materials used and any possible hidden details like underpaintings or underdrawings that might be useful in identifying the painter. The work was named *Philosopher* and was approximately dated to the 18th century at the time of purchase based on the type and appearance of the clothing of the painting's subject. The painting has a very dark background and had yellowed old varnish. The back of the painting showed water damage which does not seem to have affected the front of the painting. The damaged canvas was removed and replaced along with the decayed wood stretches.

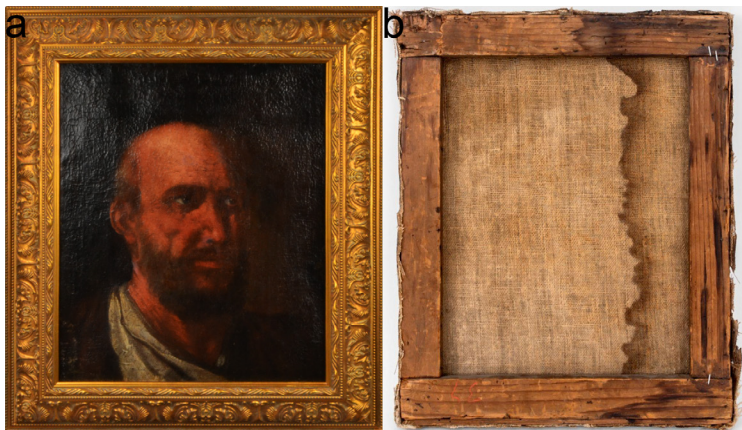
Fig 1 (a) Photo of the portrait designated as the "Philosopher". Unknown painter, oil on canvas, 13" x 16", (b) Verso of the painting, without any identifiable marking and only showing possible water damage. The old frame also had a line suggesting the water damage extended to the frame.

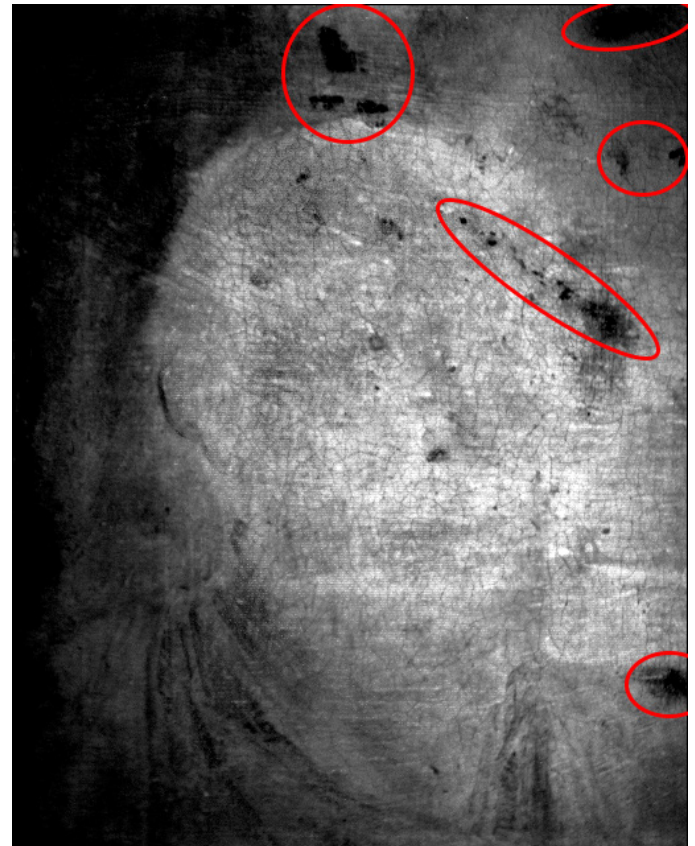
Fig 2. Combination of infrared reflectance images of the Philosopher painting with the man's face removed, highlighting dark droplets scattered across the right side of the painting, circled in red for clarity.

The RevealScan™-M system scanned visible, VNIR, and NIR regions. The main difference from the visible outer image is a long area of drops starting on the forehead and ending in a larger spot in front of the left eye of the subject on the painting. This "defect", and several other small spots that are not visible, may be spots and spills on the original canvas and possibly painted over with the dark background and do not seem to be part of an earlier underpainting.

Using RevealScan™ Analysis software to combine the 1000 nm and 1650 nm wavelength images, the man's face is deemphasized in favor of the dark "defects" making the extent of the defects stand out in comparison to the rest of the painting, see Fig. 2. In this case, the spectral imaging did not reveal a complete underpainting, only a possible paint spill on the original canvas. The painting was probably done by a sure hand, as no detailed underdrawing was shown either. Since the RevealScan™-M's series capture takes only a few minutes to collect, using this system was a great way to quickly identify an interesting feature in this painting that warrants further analysis with other time consuming methods.

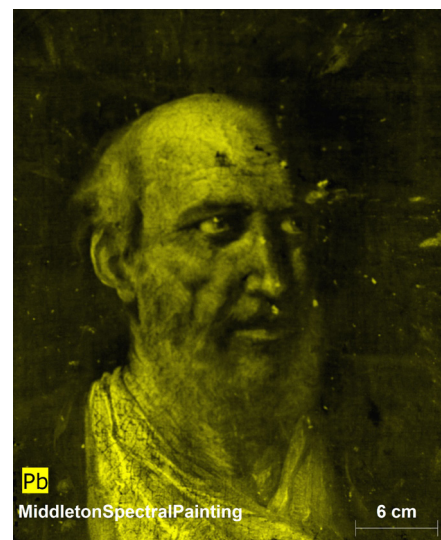
Fig 4. Pb distribution in the painting.

The ESPRIT software can automatically select which elements are detected based on the resulting spectrum of each pixel and also allows for manual adjustment of the included elements to further refine the results. A concentration map for each element or combinations of elements can also be created in the software. In the scan of Philosopher, the most evenly distributed higher level element seemed to be lead (Pb), see Fig. 4. It is obvious that lead, likely in the form of PbO white paint is used as a diluent, in the face to adjust for darkness and was in high levels in the collar area.

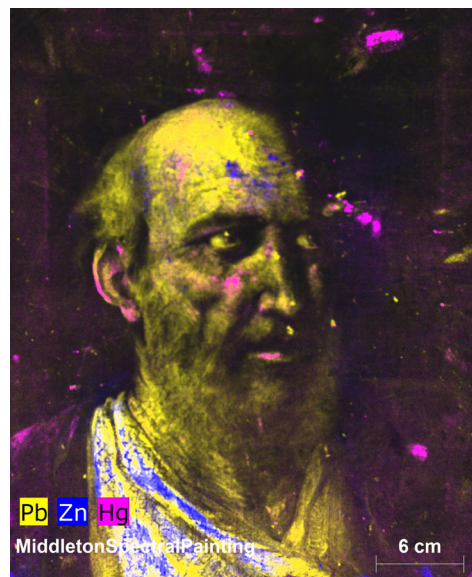
Fig 7. Element distribution of lead (yellow), zinc (blue) and mercury (violet) overlaid

Among other images of elements, it was interesting to find that mercury (Hg) was found in the same area that was highlighted in the infrared image as well (Fig. 6). Vermillion is the only pigment that contains mercury in substantial quantities and it was extensively used in old paintings as a red paint. The “spill”, which is not an integral part of the painting, thus was identified as vermilion. Looking at the Hg elemental image it seems that red was used to highlight the reddish color of the ear and the lip of the gentleman on the painting. Other small spots are possibly spills or earlier contaminants on the canvas under the paint of the portrait. For better comparison of the main elements, a combined element map of zinc, lead, and mercury is shown in Fig. 7.
